## CRACK FORMATION PROCESS IN ARCH DAM FOUNDATION

M. A. KALABEGISHVILI

*This report presents theoretical solution and analysis of stress state and correspondingly seepage process in arch dam tectonic foundation. Such as demonstrative object is represented Enguri HPP arch dam.*

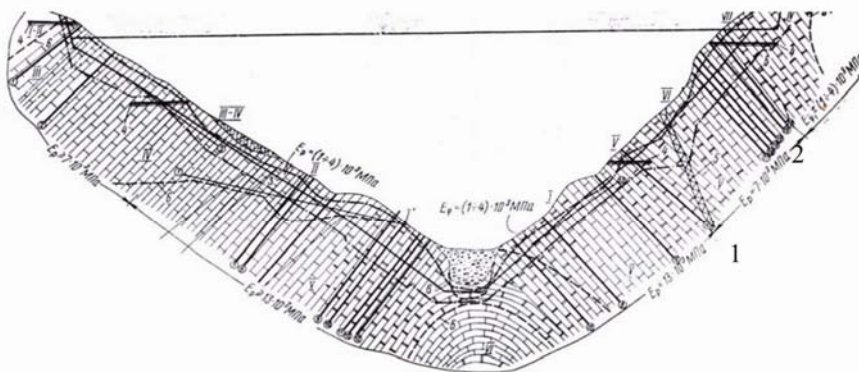
The dam foundation has rather complex geological structure (fig. 1.1, 1.2). There are anticline strata in the central part of the foundation that consist of least permeable soils. A low-permeability breccia stratum located 150m upstream from the dam continues along the existing layers in the foundation, and spreads for 200 meters from the dam base. Thus, the seepage flow sharply narrows at the lower border of the grout curtain, resulting in additional flooding of the rock massif located in front of the curtain, which causes increased readings in piezometers located there. There are tectonic faults in the base that are filled with clayey material and screen back the seepage flow, which explains the difference in readings between piezometers located at some distance from each other.

fig. 1.1 geological cross section.  
1-major geological fracture; 2- geological cracks.

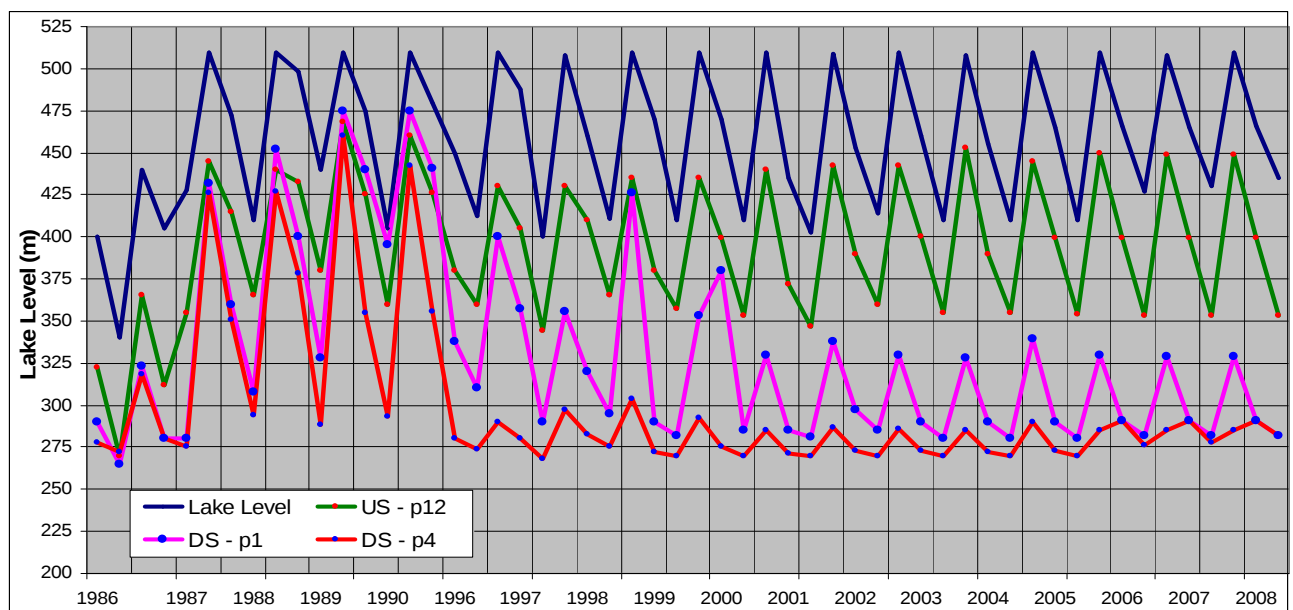
In the period of first reservoir filling (since 1986) when the water level in the reservoir reached 460 meters, there were spasmodic rises of pressures (heads) behind the grout curtain, a trend occurring with increasing frequency compared to previous years (fig. 2). In 1989-1990 (NOL=510 m), monitored pressures in piezometers located in that zone constituted about 80-90 per cent of pressures at the dam, which indicated that the grout curtain was damaged.

Figure 2. Piezometer pressure distribution:  
p1, p4 - behind the grout curtain; p12 - before the grout curtain

pressure dam face are filled and then covered by clayey mud. This increases hydrostatic pressure on the crack surface and decreases friction. When the reservoir is full, the increased pressured inside the crack fosters further cracking, and when the water is at the lowest level, cracks that are subject to compressive stresses (because of low friction on the surface) may also develop further. The fact that the cracks get filled with mud is also reflected in the piezometer readings (Figure 2).

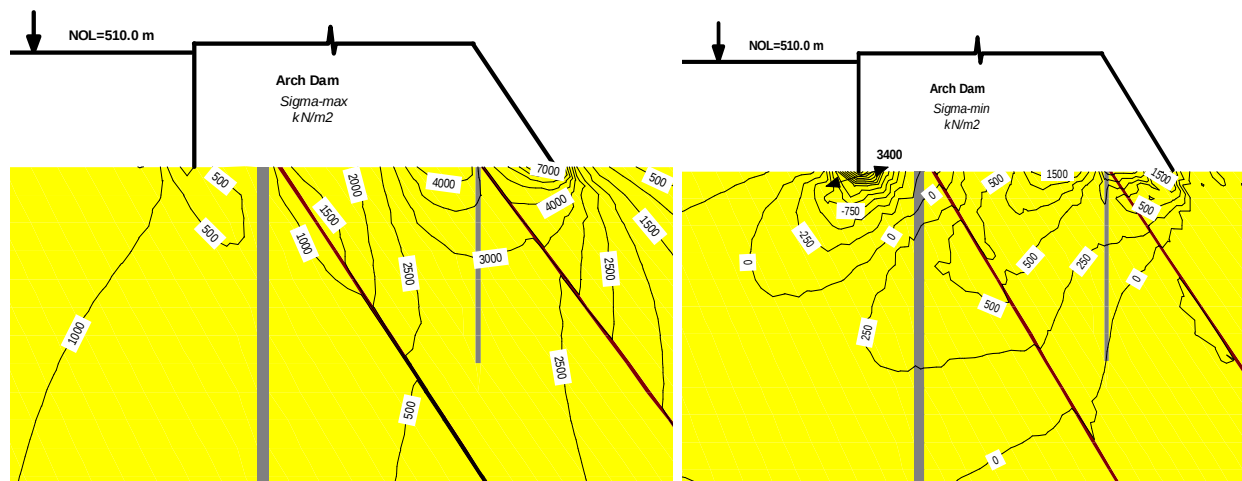
Figure 3. Main stress distribution in foundation of dam central cantilever (according to 3D model).

- According to the 3D dam-foundation model, there is a wide range of main stresses in the central cantilever section (Figure 4). Tensile stresses penetrate deep into the foundation (Figure 3);
- At the water level of 450 m in the reservoir, opening of the dam-foundation contact zone was registered under the pressure face. In the same time the grout curtain was still strong enough (according to piezometer readings, Figure 2).
- The depth of crack (0-1) reached 7.5 m and its orientation almost followed the dip of strata (figure 9).

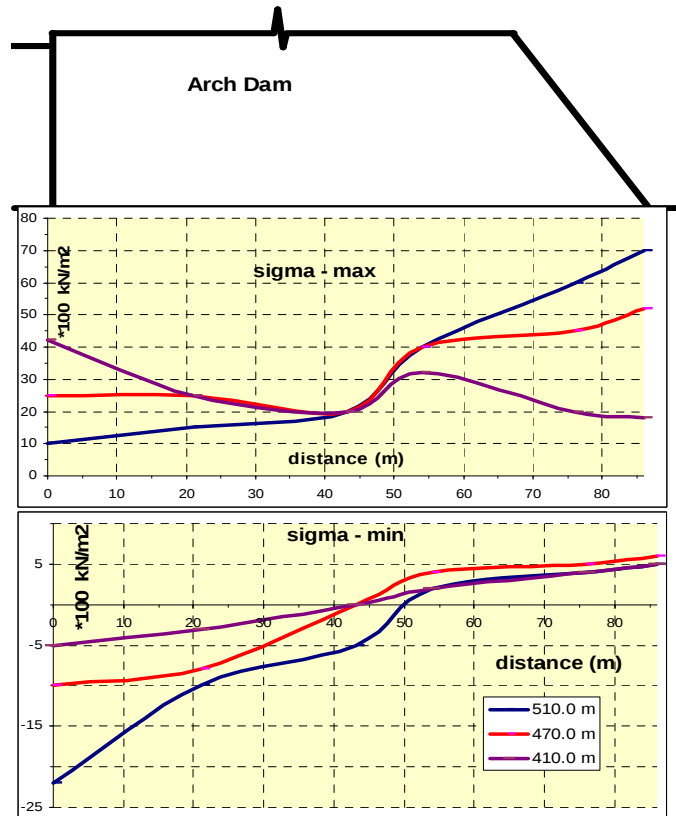
Figure 4. Main stress distribution in dam-foundation contact

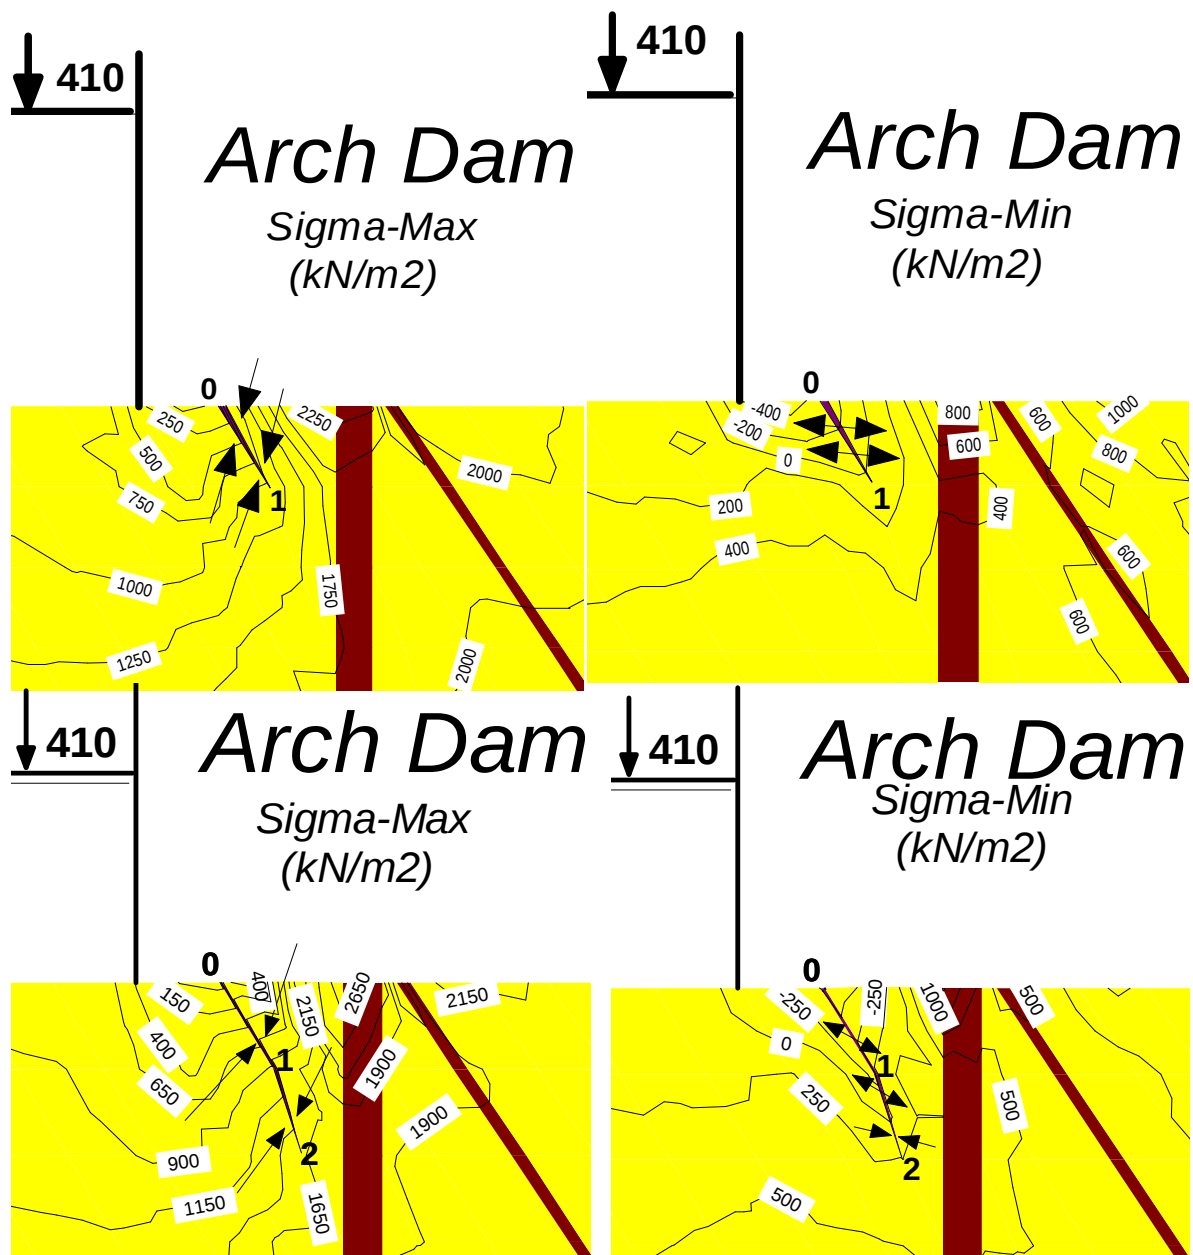
The inclined crack located under the pressure face of the dam (0-1) is subject to high compressive stress during reservoir drawdown (Figure 6), so that the crack shear resistance needs to be investigated. According to Griffith criteria modified by McClintock and Walsh, the critical stress (Figure 5), is defined as follows [2,3]:

Figure 6. Crack development dynamics in the dam foundation (under compressive stress) during reservoir low level.

The calculations show that in the interval of  $\mu = 0.2 \div 0.8$  the safety factor for the 0-1 crack is exhausted (Figure 7). A new crack 1-2 developed almost vertically to the length of 3 meters (Figure 6).

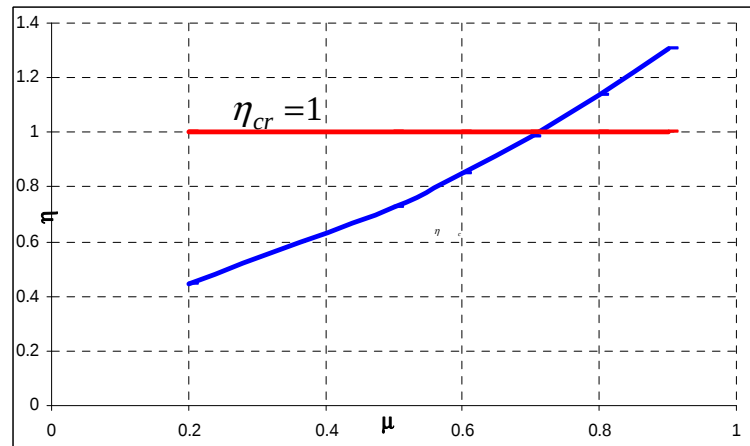
Figure 7. Shear crack stability to different surface frictions

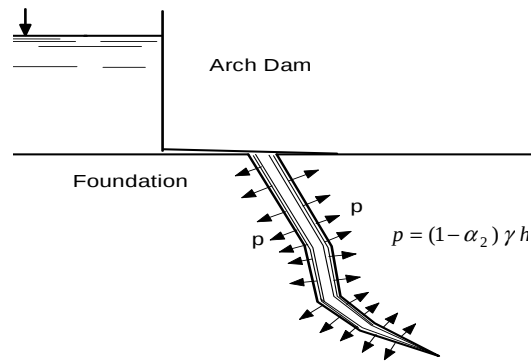
During subsequent reservoir filling, the crack became longer compared to the previous time (0-1-2), and the surfaces were partly covered with mud (as confirmed by peizometer data), which respectively caused decrease of  $\alpha_2$  (Figure 8).

Figure 8. Crack modeling during mud filling

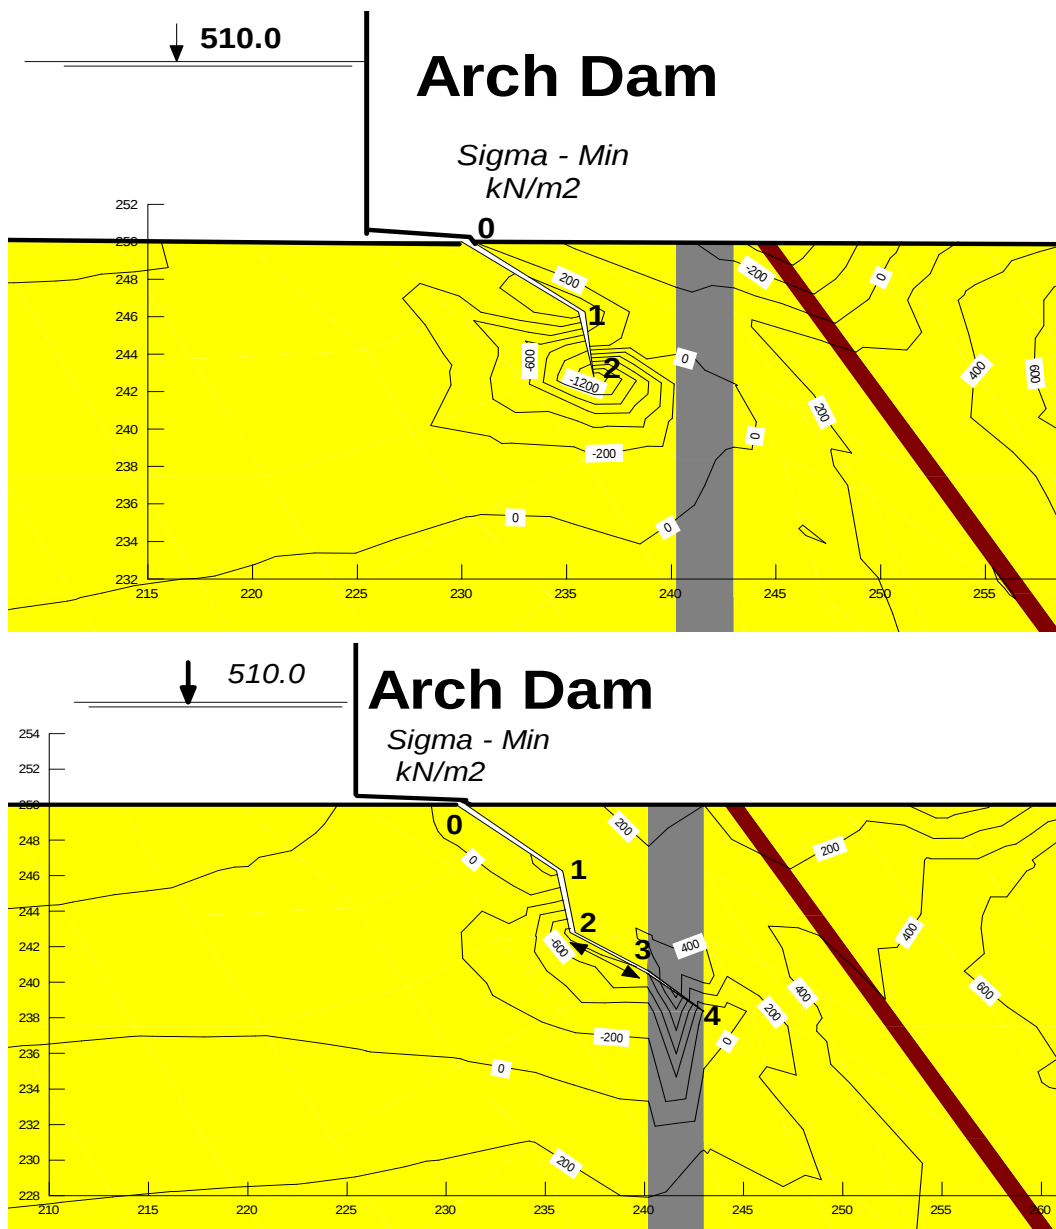
The calculations show that crack started to develop at  $\alpha_2 = 0.1 \div 0.2$ . The crack actually damaged the grout curtain. The overall length of the 0-1-2-3-4 crack was 12 meters (Figure 9).

Figure 9. Crack development dynamics in the dam foundation during Subsequent Reservoir Filling  
 0-1 – tensile developed during first filling of the reservoir (NOL=510 m); 1-2 – shear crack developed during drawdown (MinOL=410 m); 2-3-4 – tensile crack developed during re-filling (NOL=510 m)

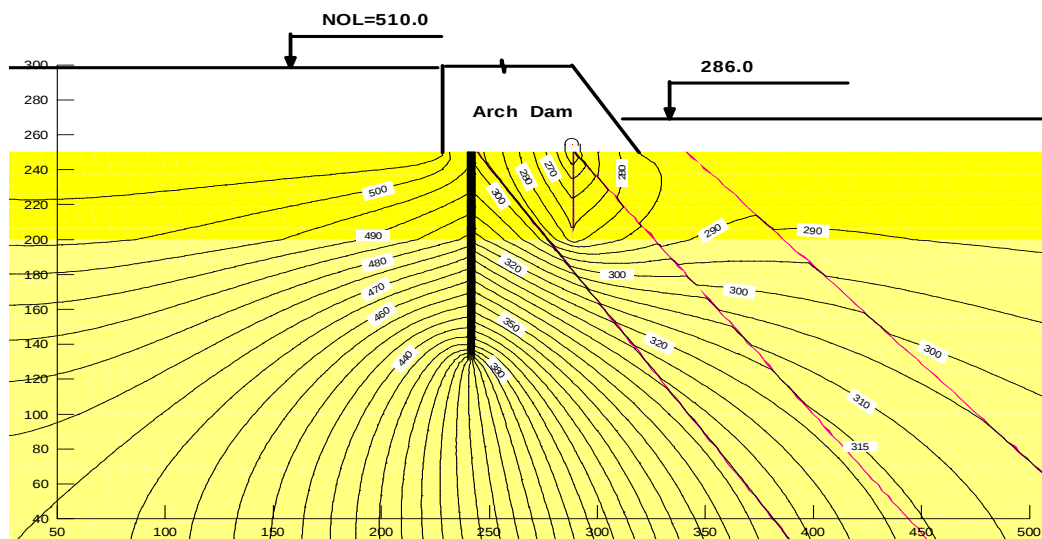
Figure 10. Pressure distribution in the dam foundation with the intact grout curtain and drainage in place

In view of the foundation geology, also behavior of the grout curtain and drainage, the obtained pressure distribution (Figure 10) well corresponds to measurements made in peizometers. Dam foundation non-uniformity, in particular, screening tectonic faults, have a significant impact of the seepage regime. Under the influence of drainage, pressure in the area in front of it decreased by up to 20 per cent (Figure 12). After the contract crack of 0-1-2-3-4 in the foundation damaged the grout curtain, the seepage regime sharply changed (Figure 11), which also corresponds to results of piezometer measurements.

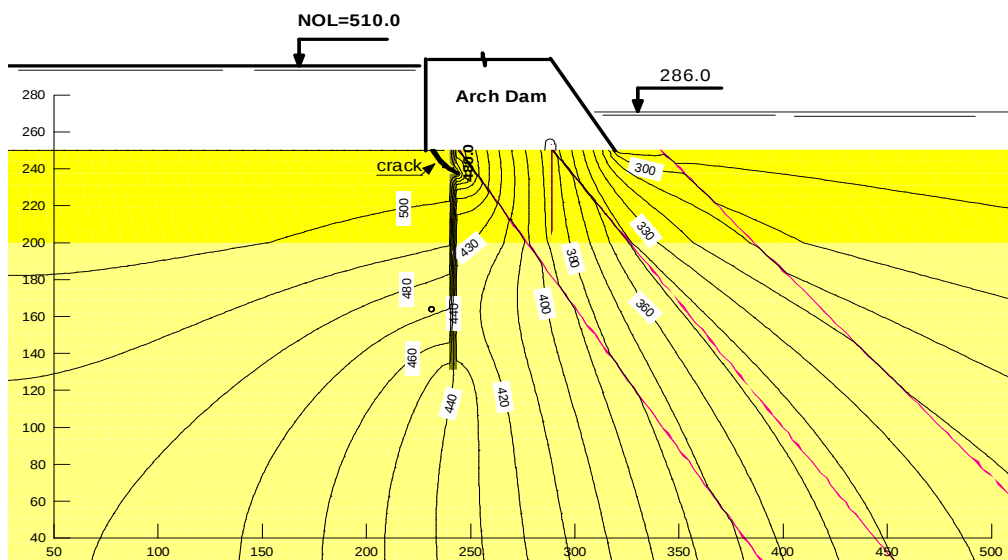
Figure 11. Pressure distribution in the dam foundation with the damaged grout curtain and drainage
