## CRACK FORMATION PROCESS IN ARCH DAM FOUNDATION

M. A. KALABEGISHVILI

*This report presents theoretical solution and analysis of stress state and correspondingly seepage process in arch dam tectonic foundation. Such as demonstrative object is represented Enguri HPP arch dam.*

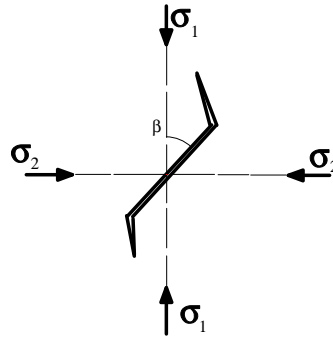
The inclined crack located under the pressure face of the dam (0-1) is subject to high compressive stress during reservoir drawdown (Figure 6), so that the crack shear resistance needs to be investigated. According to Griffith criteria modified by McClintock and Walsh, the critical stress (Figure 5), is defined as follows [2,3]:

Figure 5. shear crack development scheme

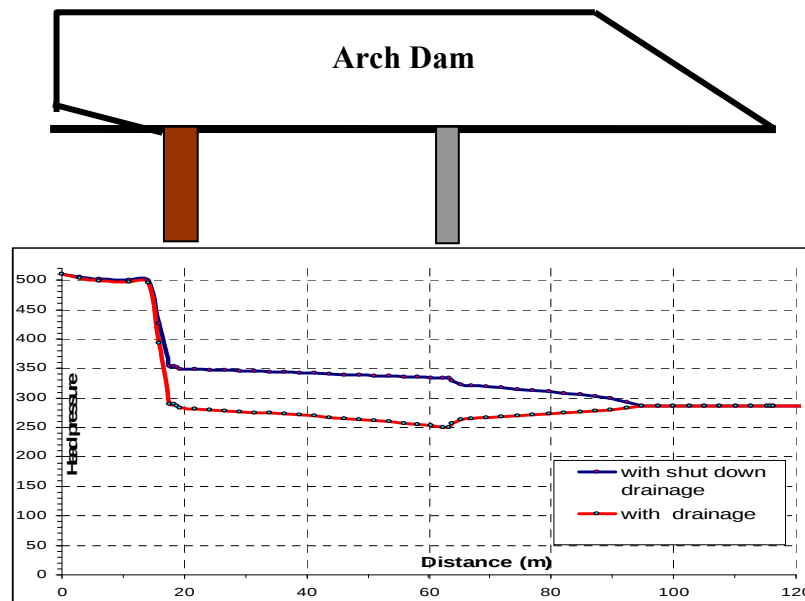
Figure 12. Pressure (head) distribution in the dam-foundation contact
